AFWAL-TR-82-2121
Volume I

STRUCTURAL ELEMENT AND REAL BLADE IMPACT TESTING

UNIVERSITY OF DAYTON RESEARCH INSTITUTE
300 COLLEGE PARK AVENUE
DAYTON, OHIO 45469

FINAL REPORT FOR PERIOD OCTOBER 1977 - JUNE 1980

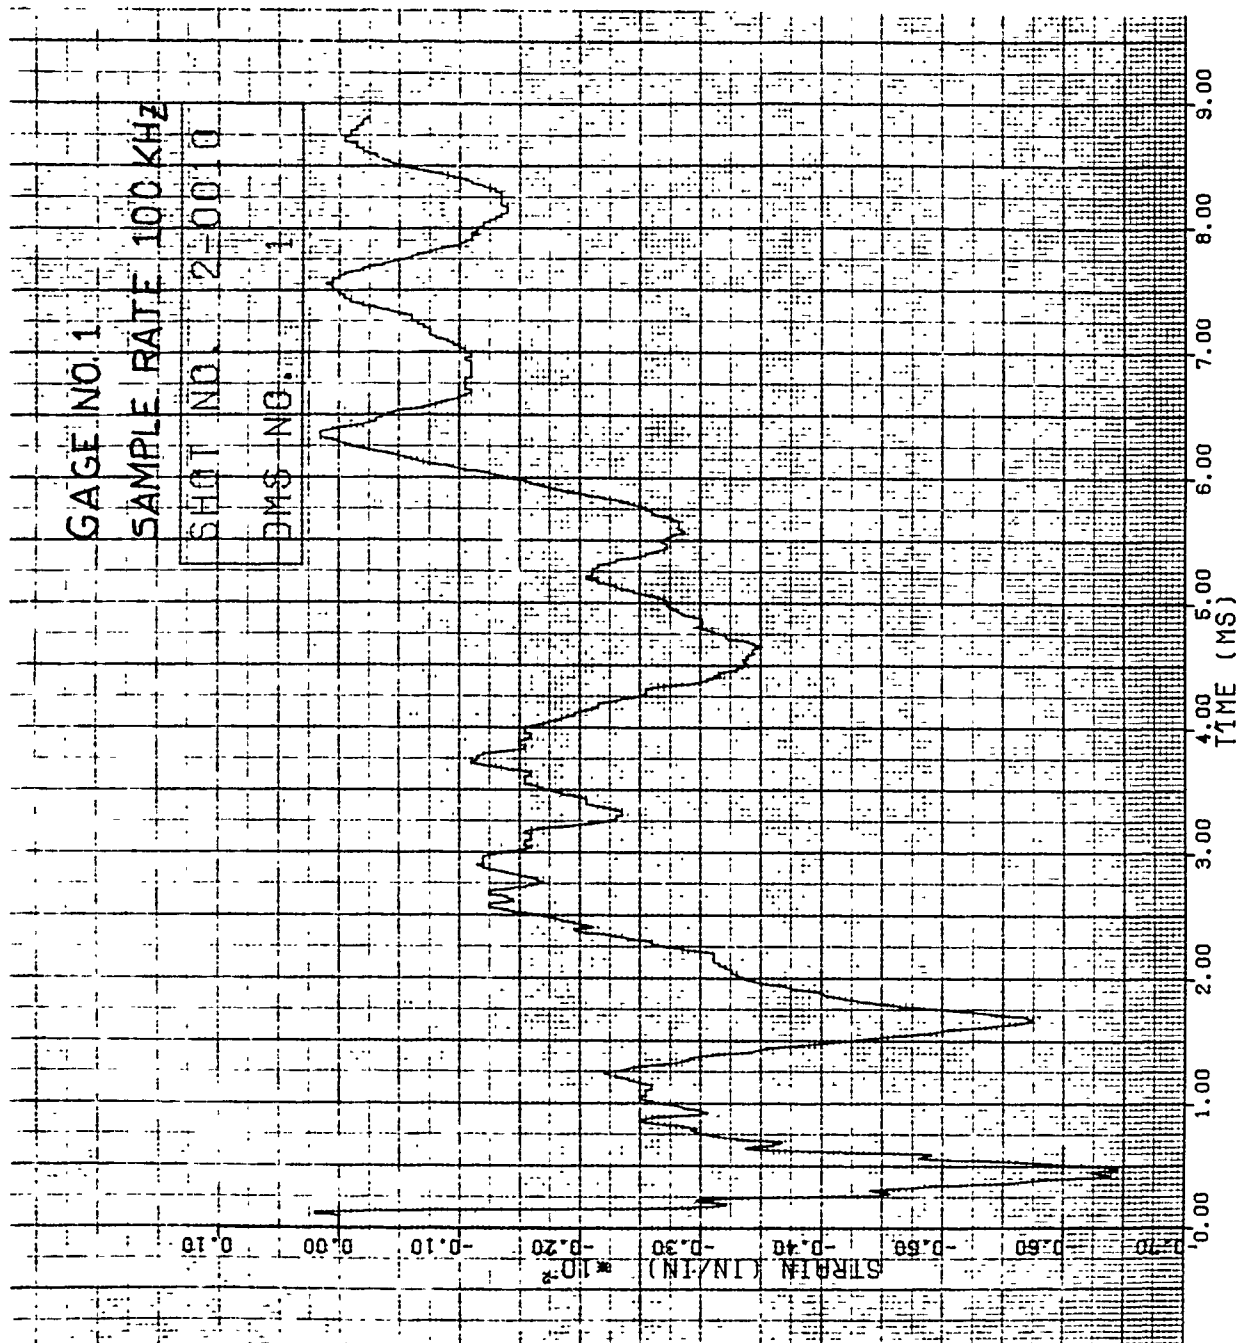
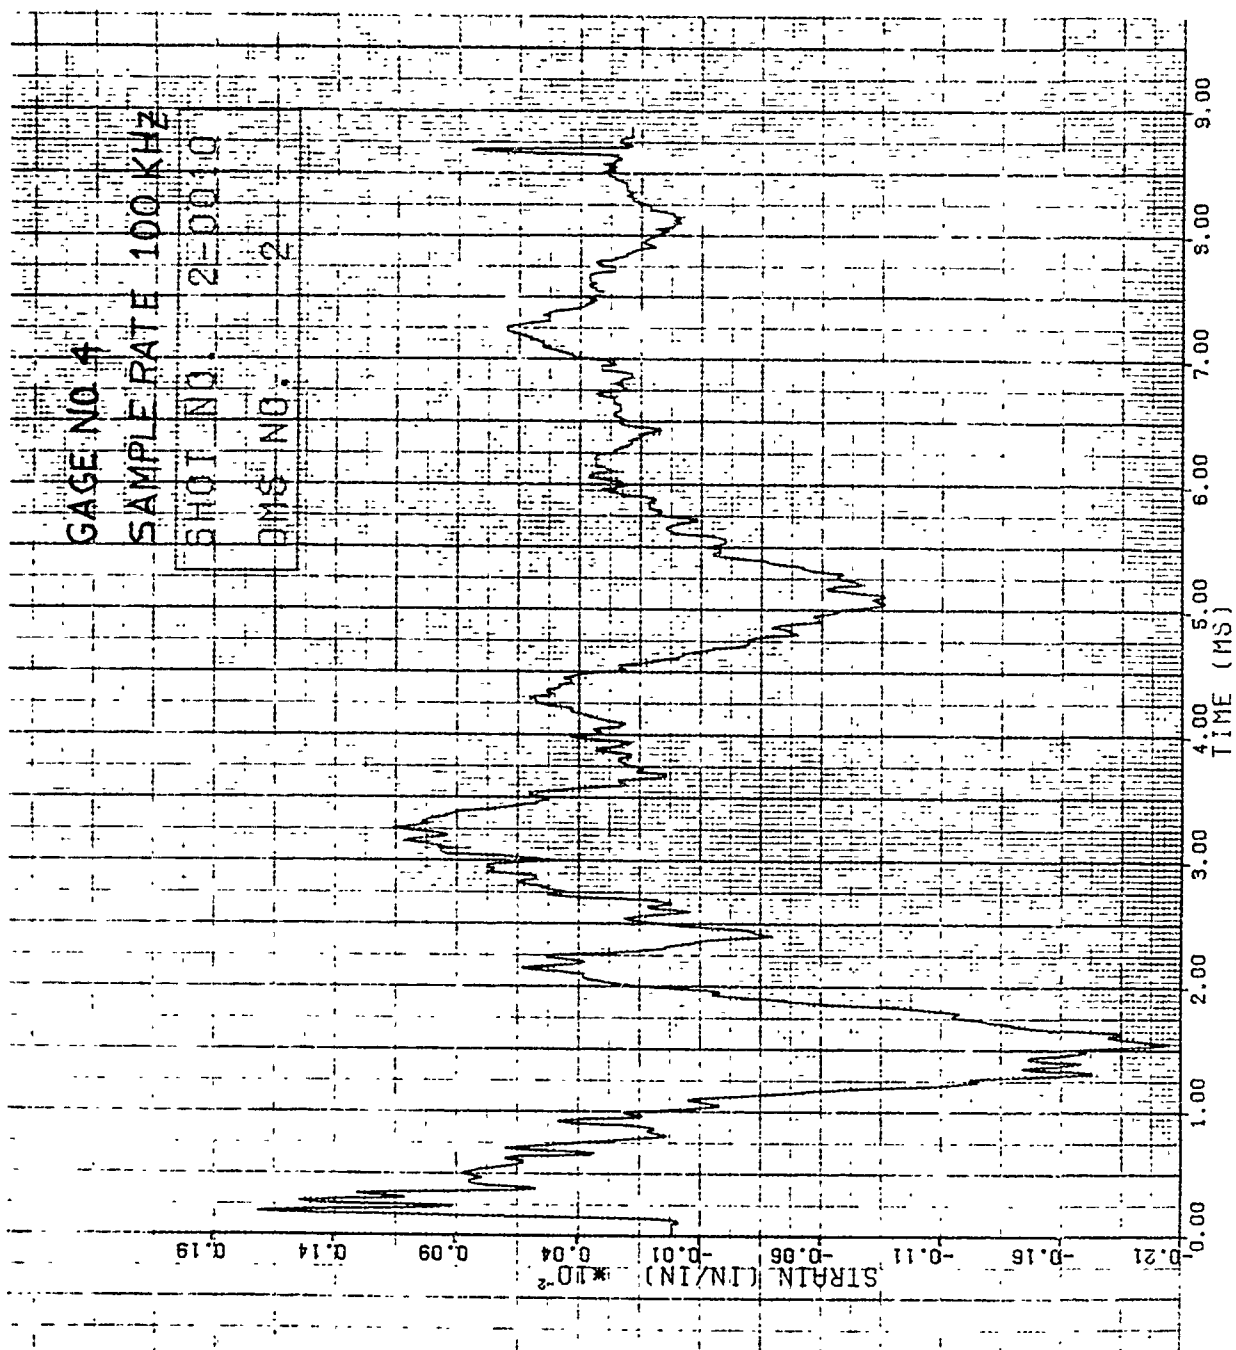
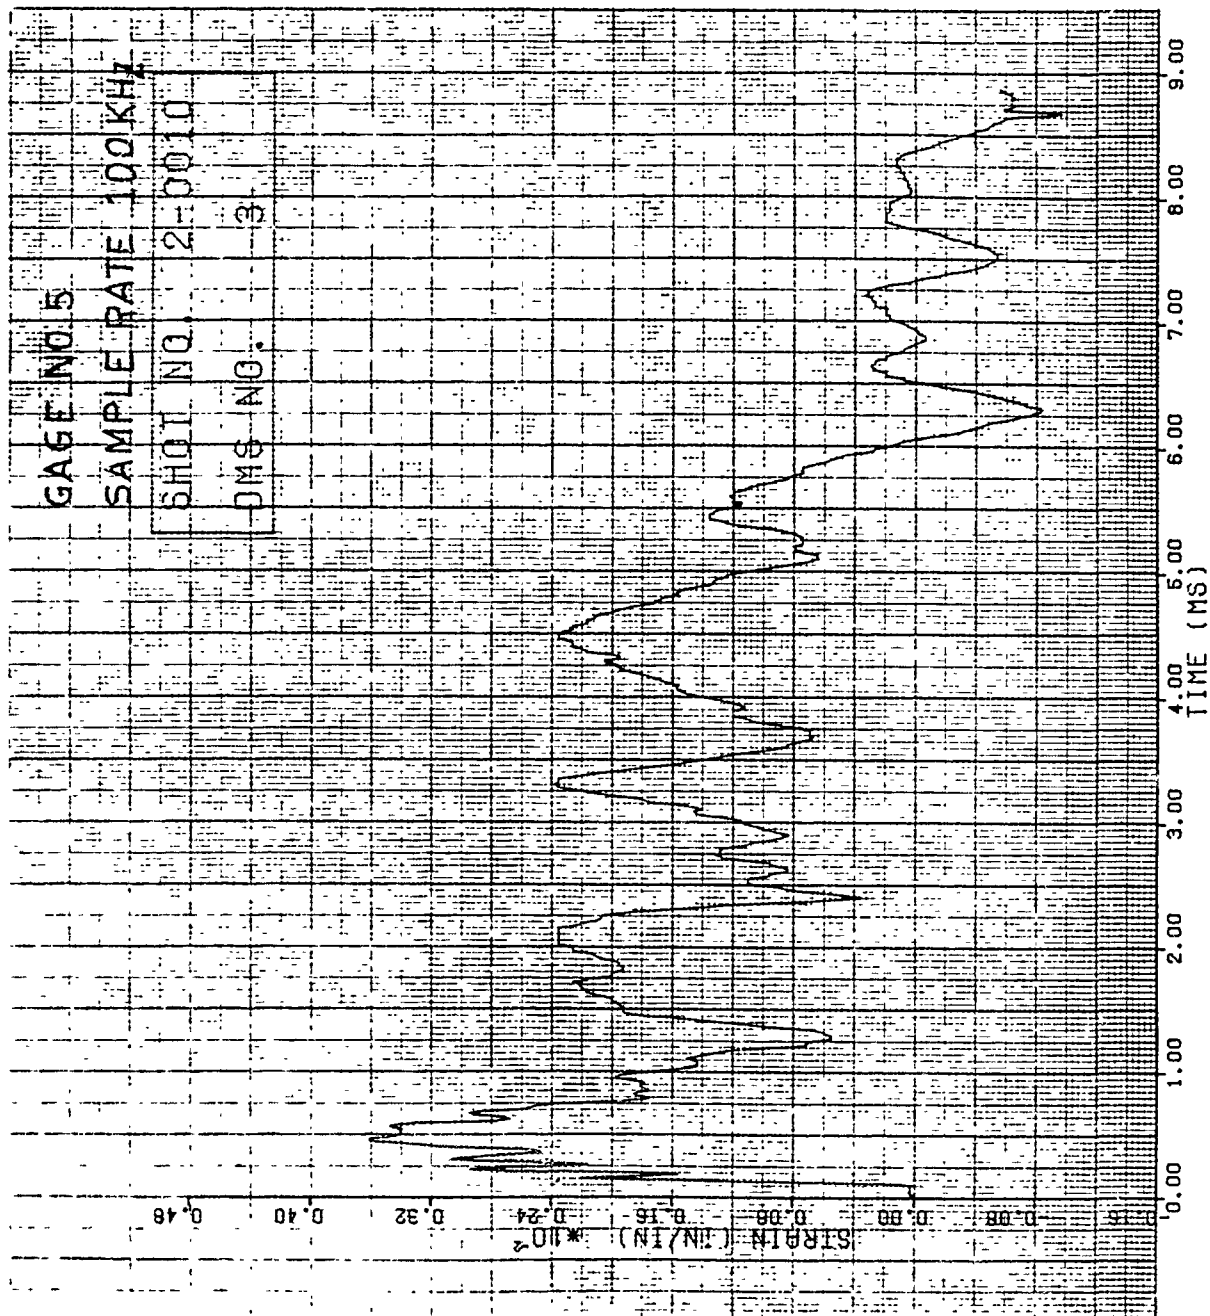
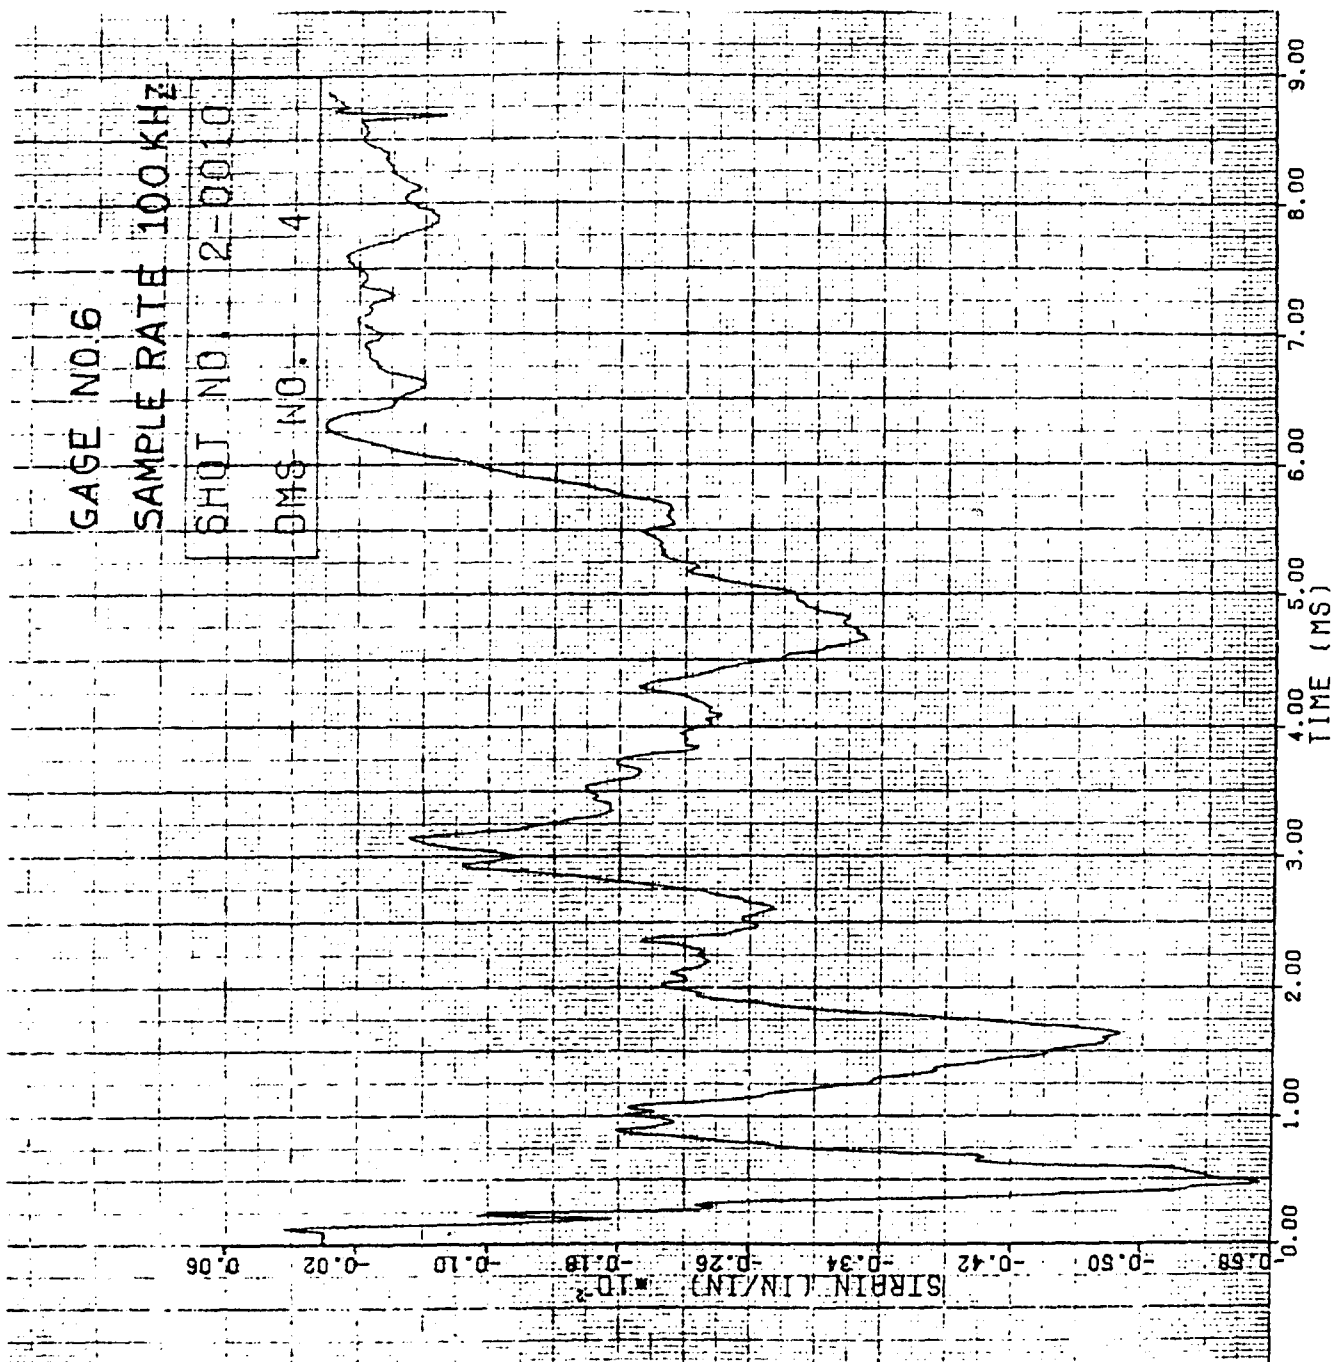
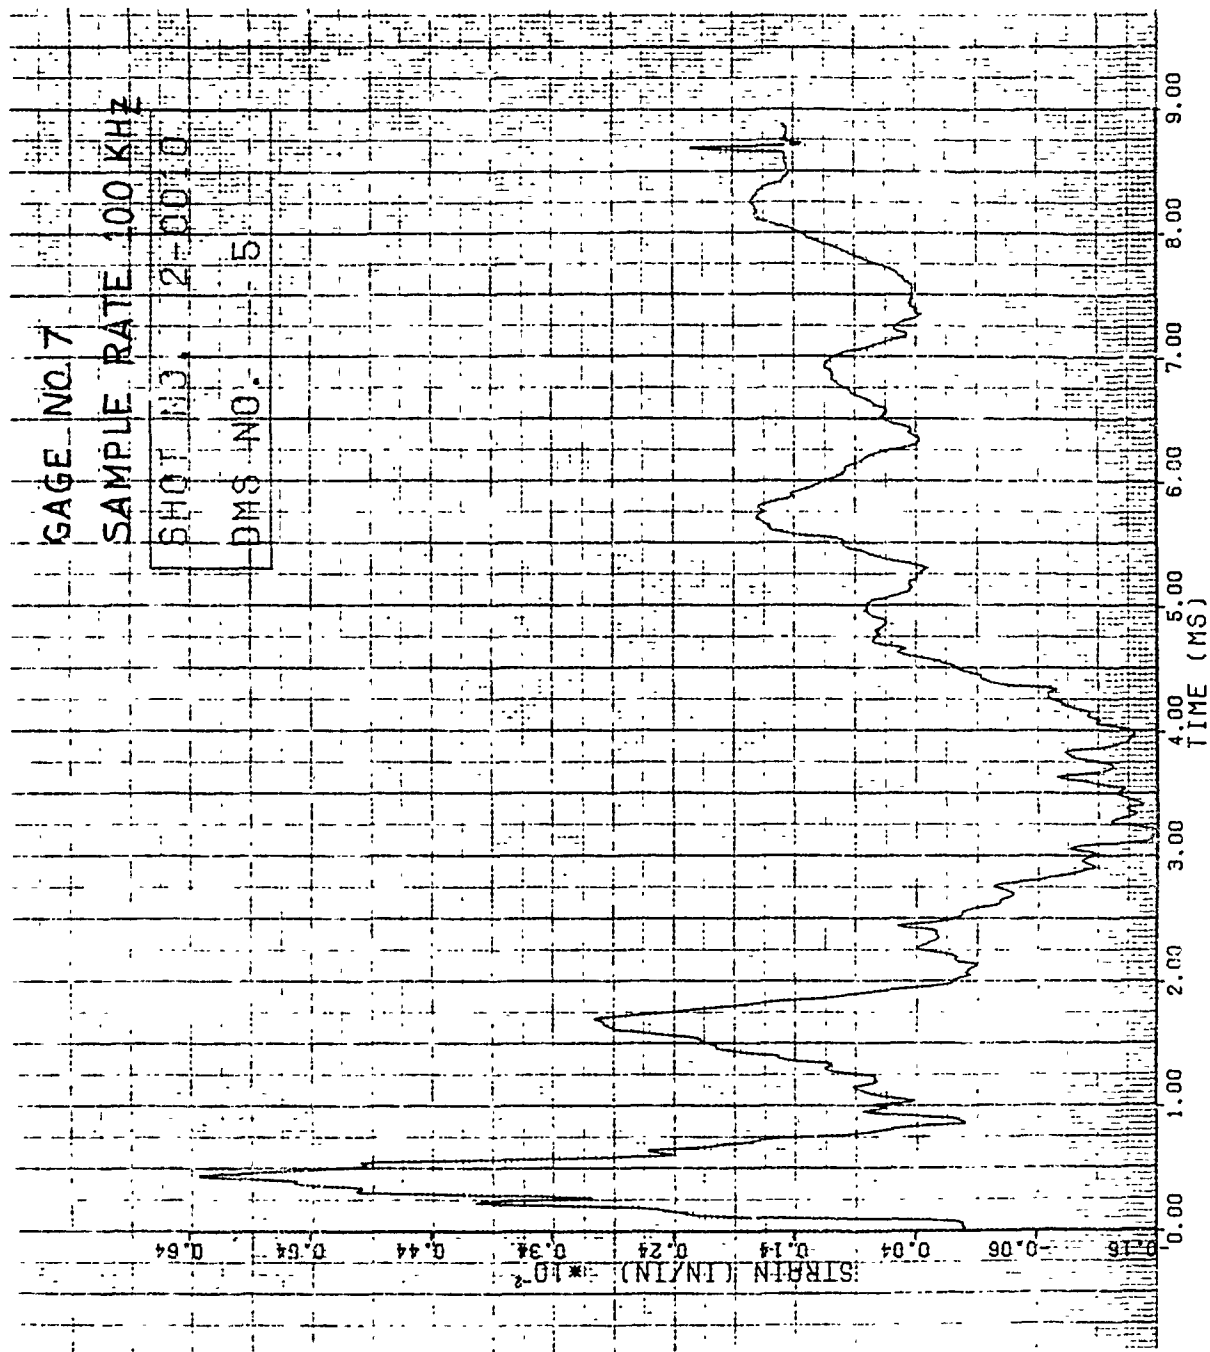
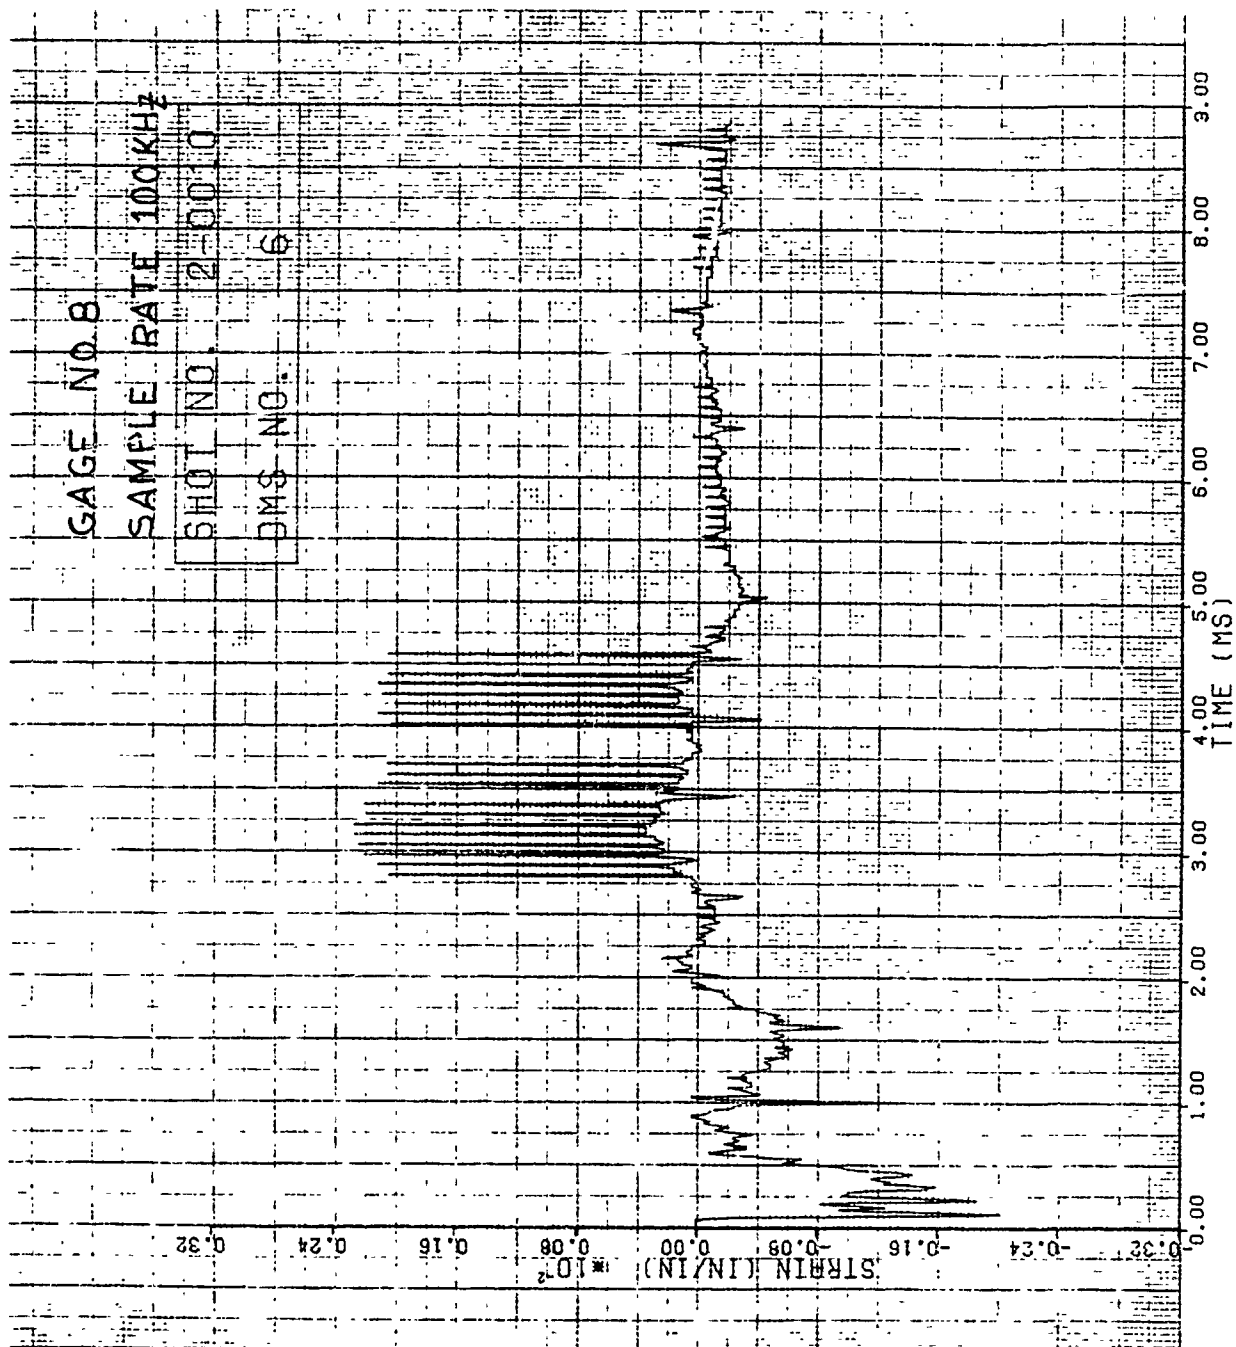
Strain versus time data are also given in Figures 210 through 215 for Shot 2-0010 for an impact velocity of 200 m/s and impact mass of 48.1 g. The strain for this higher velocity shot is considerably greater than for the lower velocity shot.

Figure 210. Strain of Shot 2-0010 for Gage #1.

Figure 211. Strain of Shot 2-0010 for Gage #4.

Figure 212. Strain of Shot 2-0010 for Gage #5.

Figure 213. Strain of Shot 2-0010 for Gage #6.

Figure 214. Strain of Shot 2-0010 for Gage #7.

Figure 215. Strain of Shot 2-0010 for Gage #8.

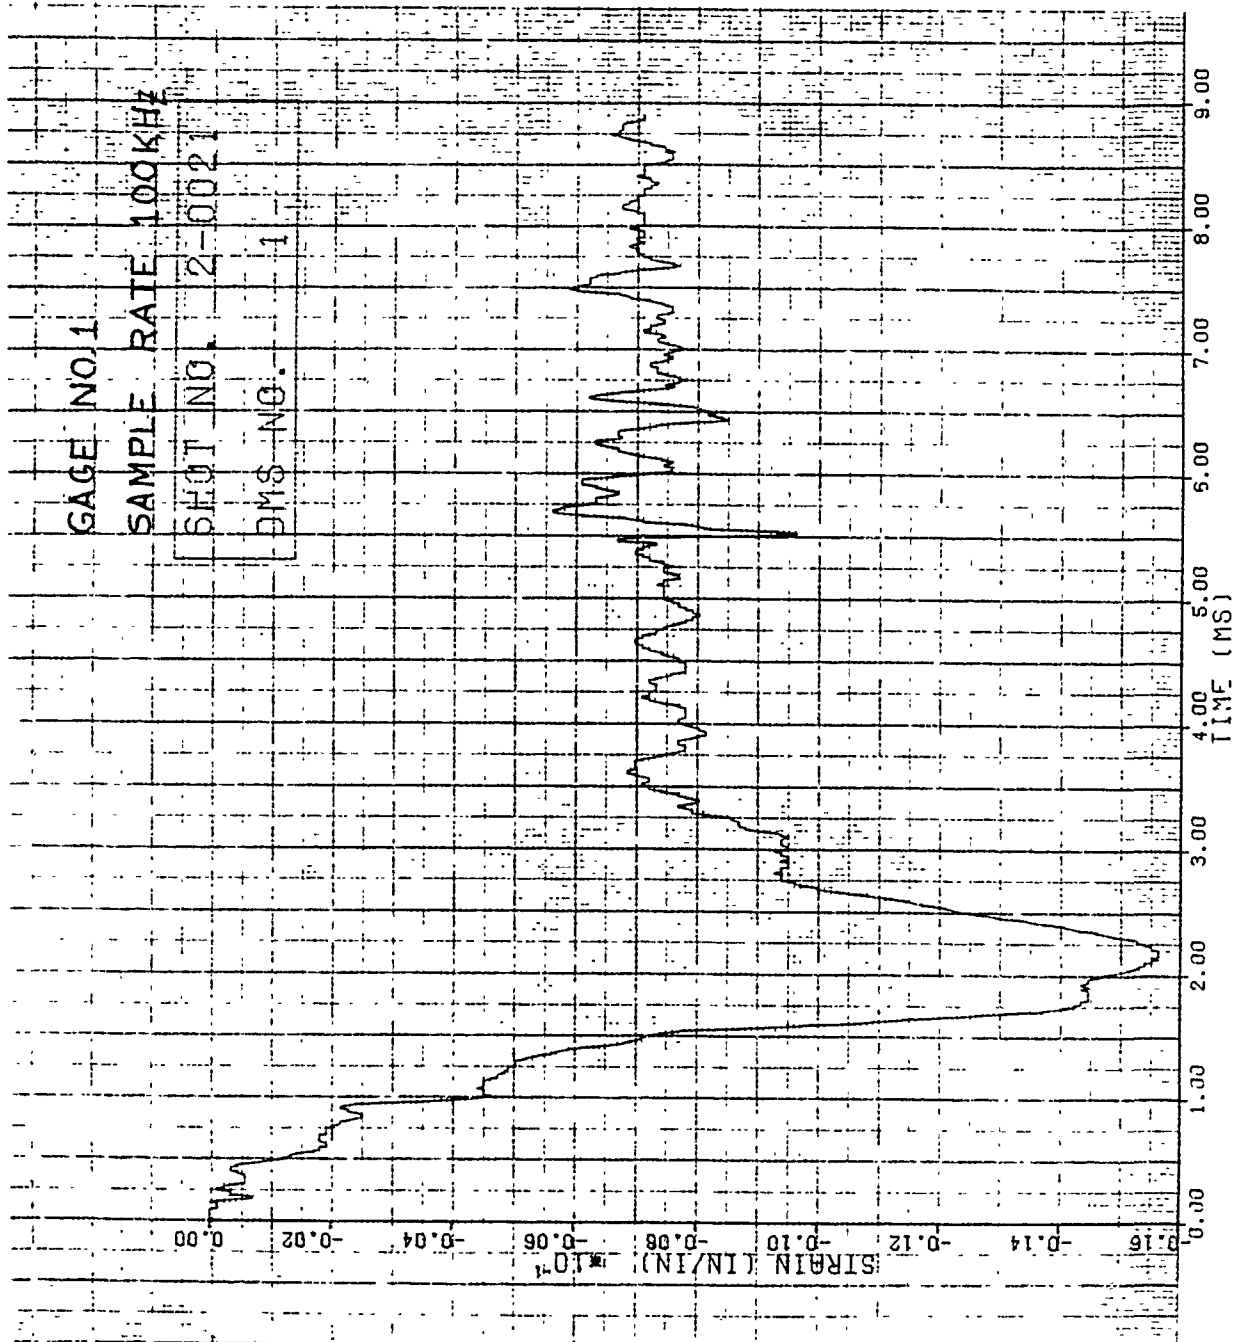
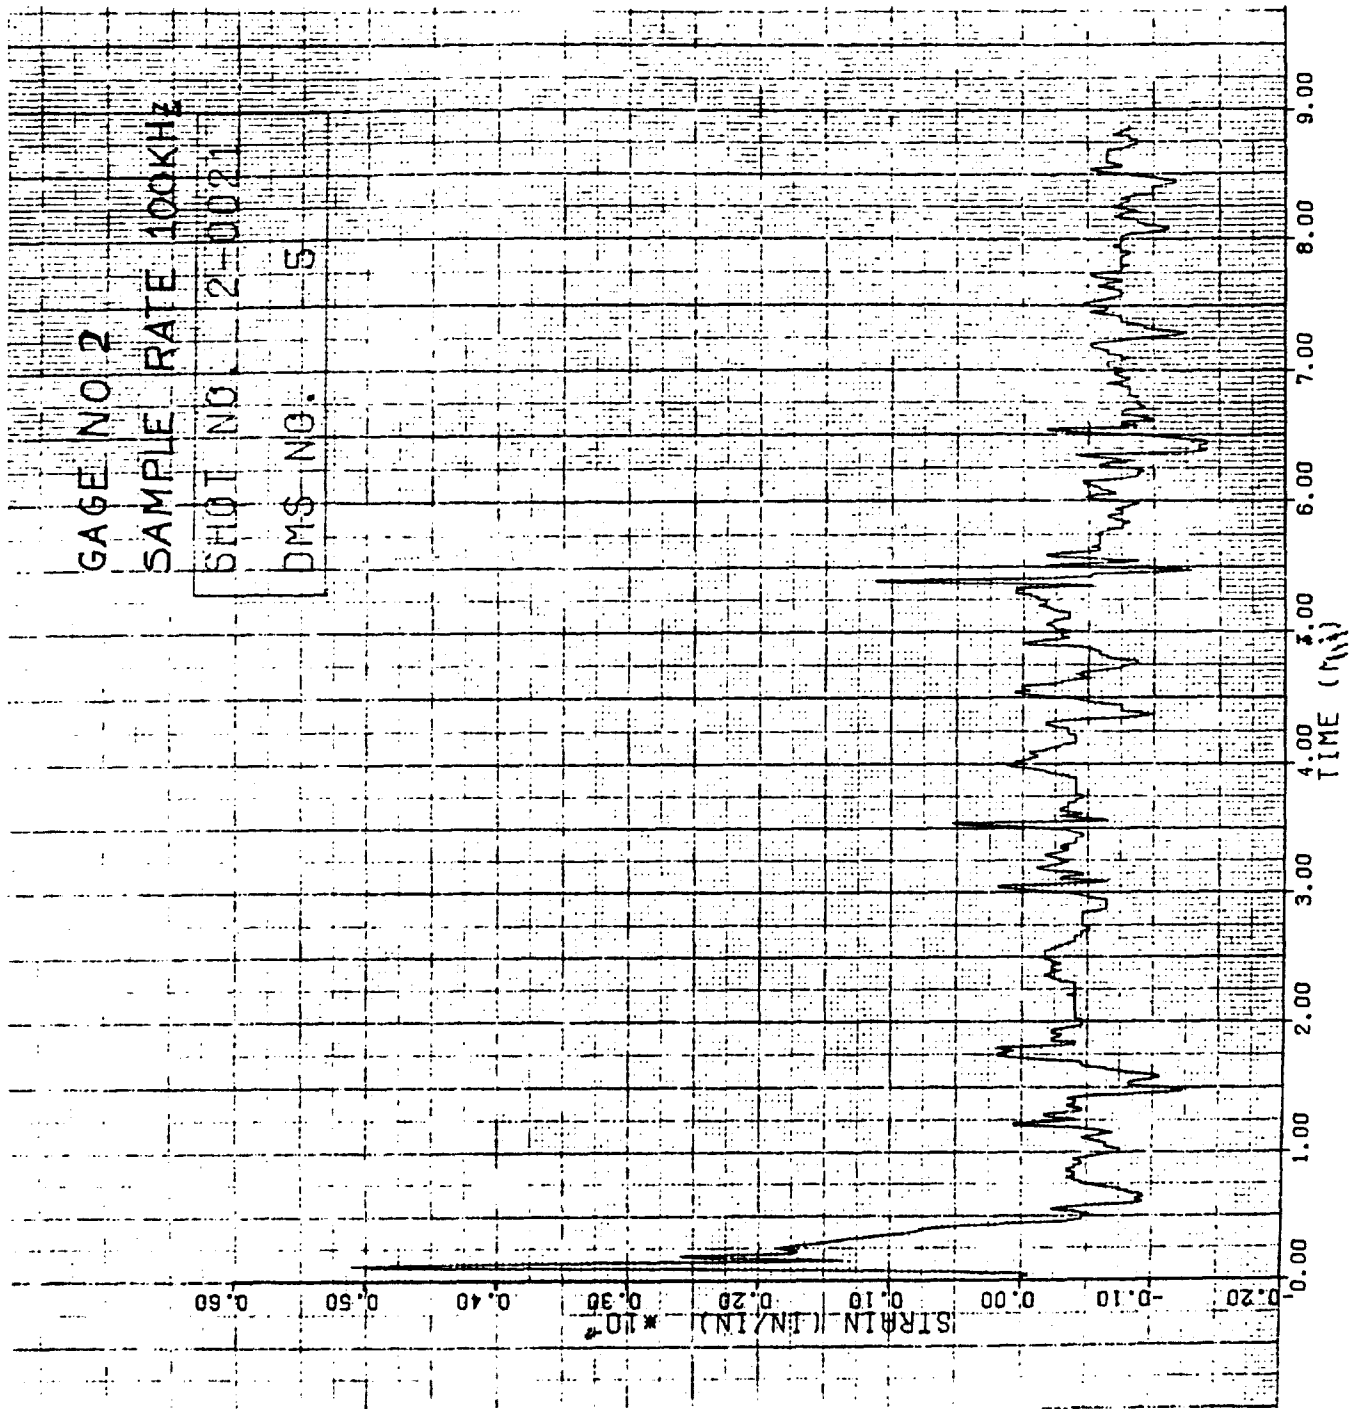
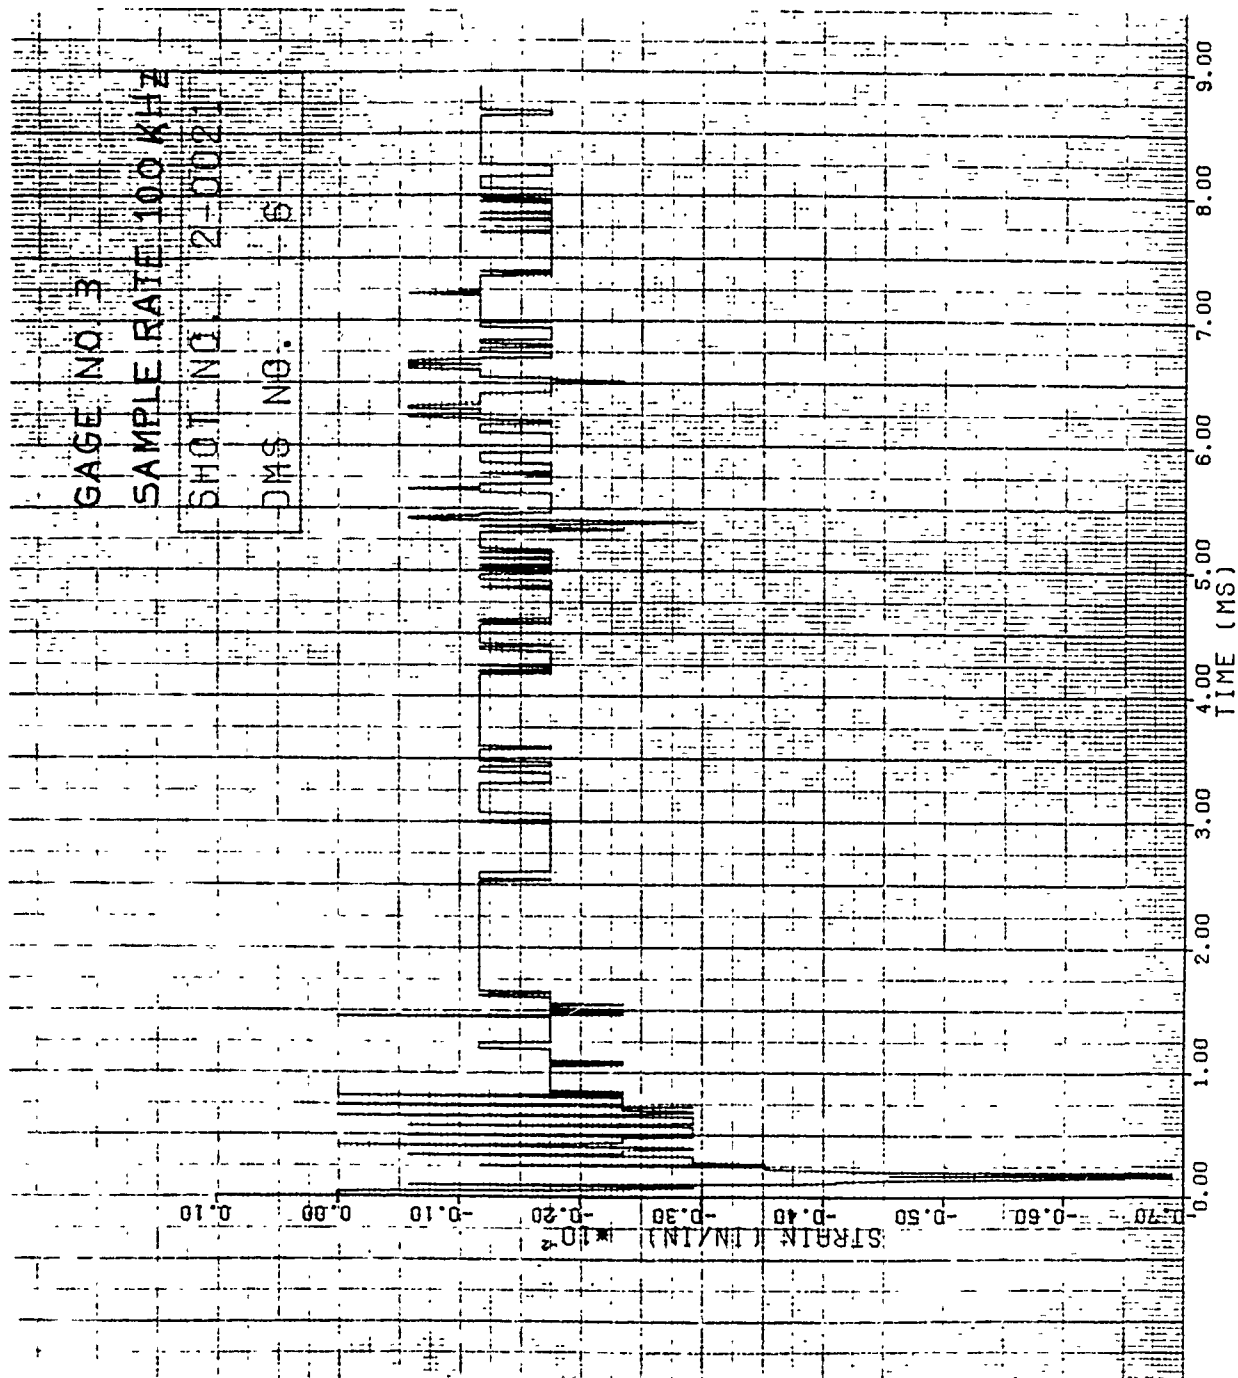
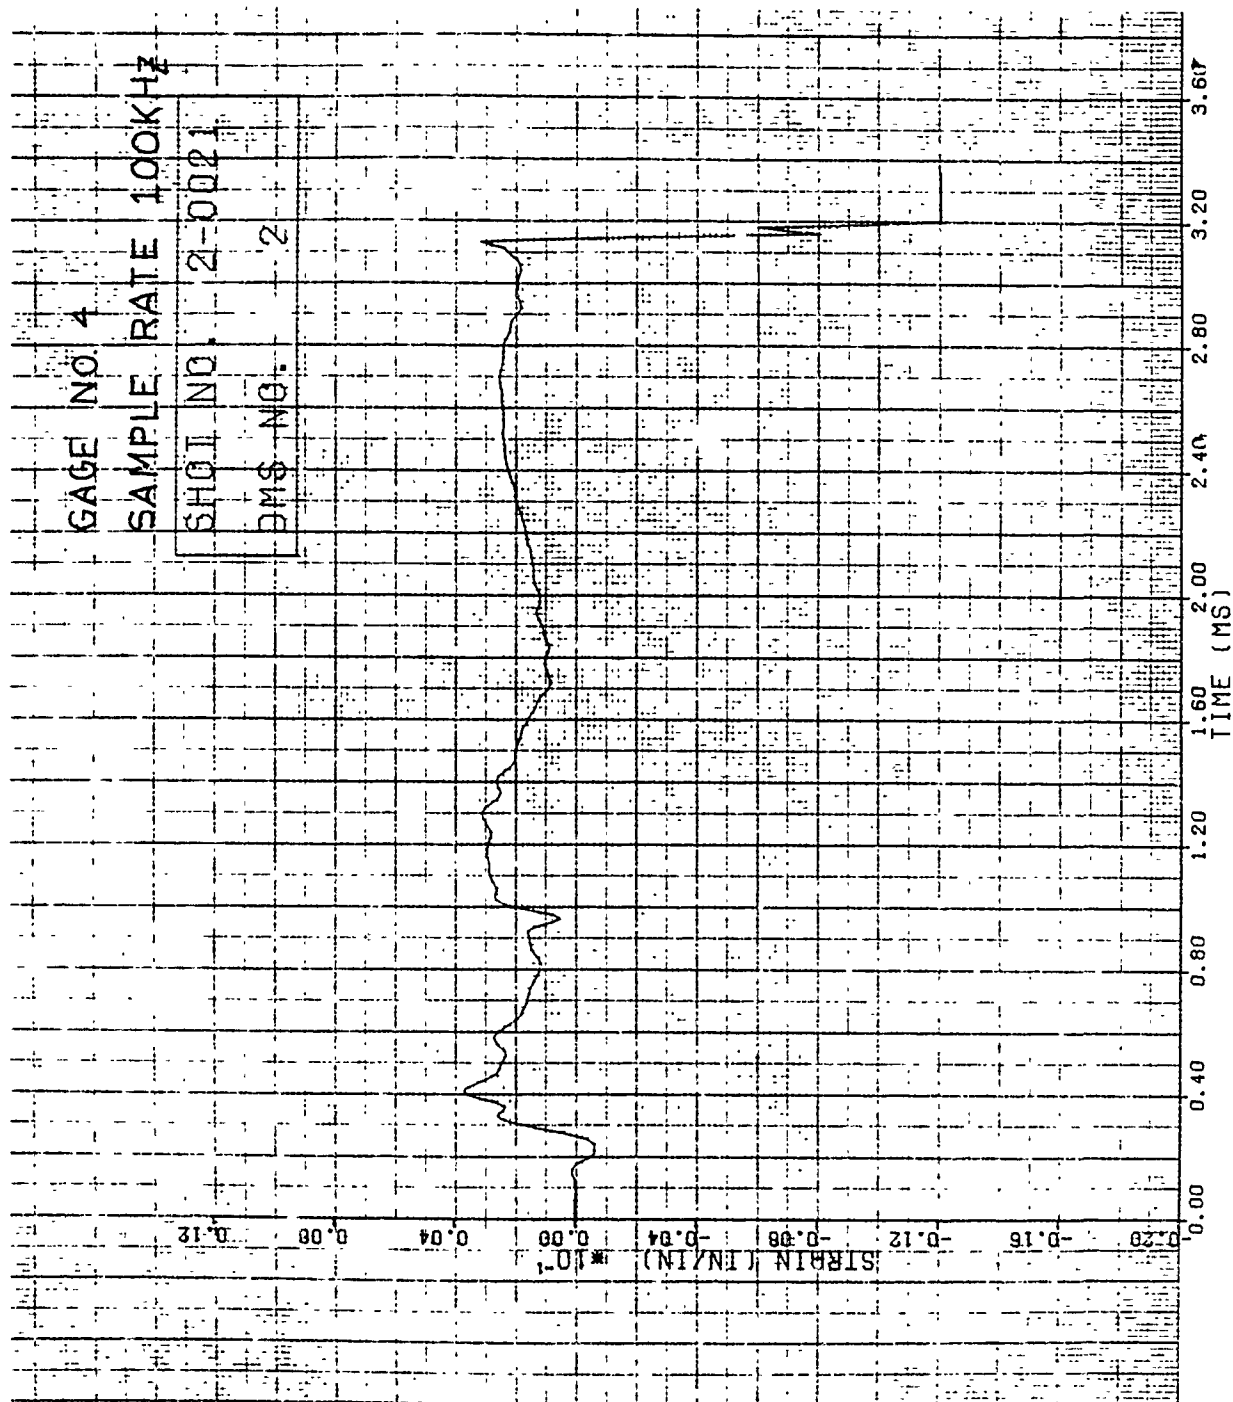
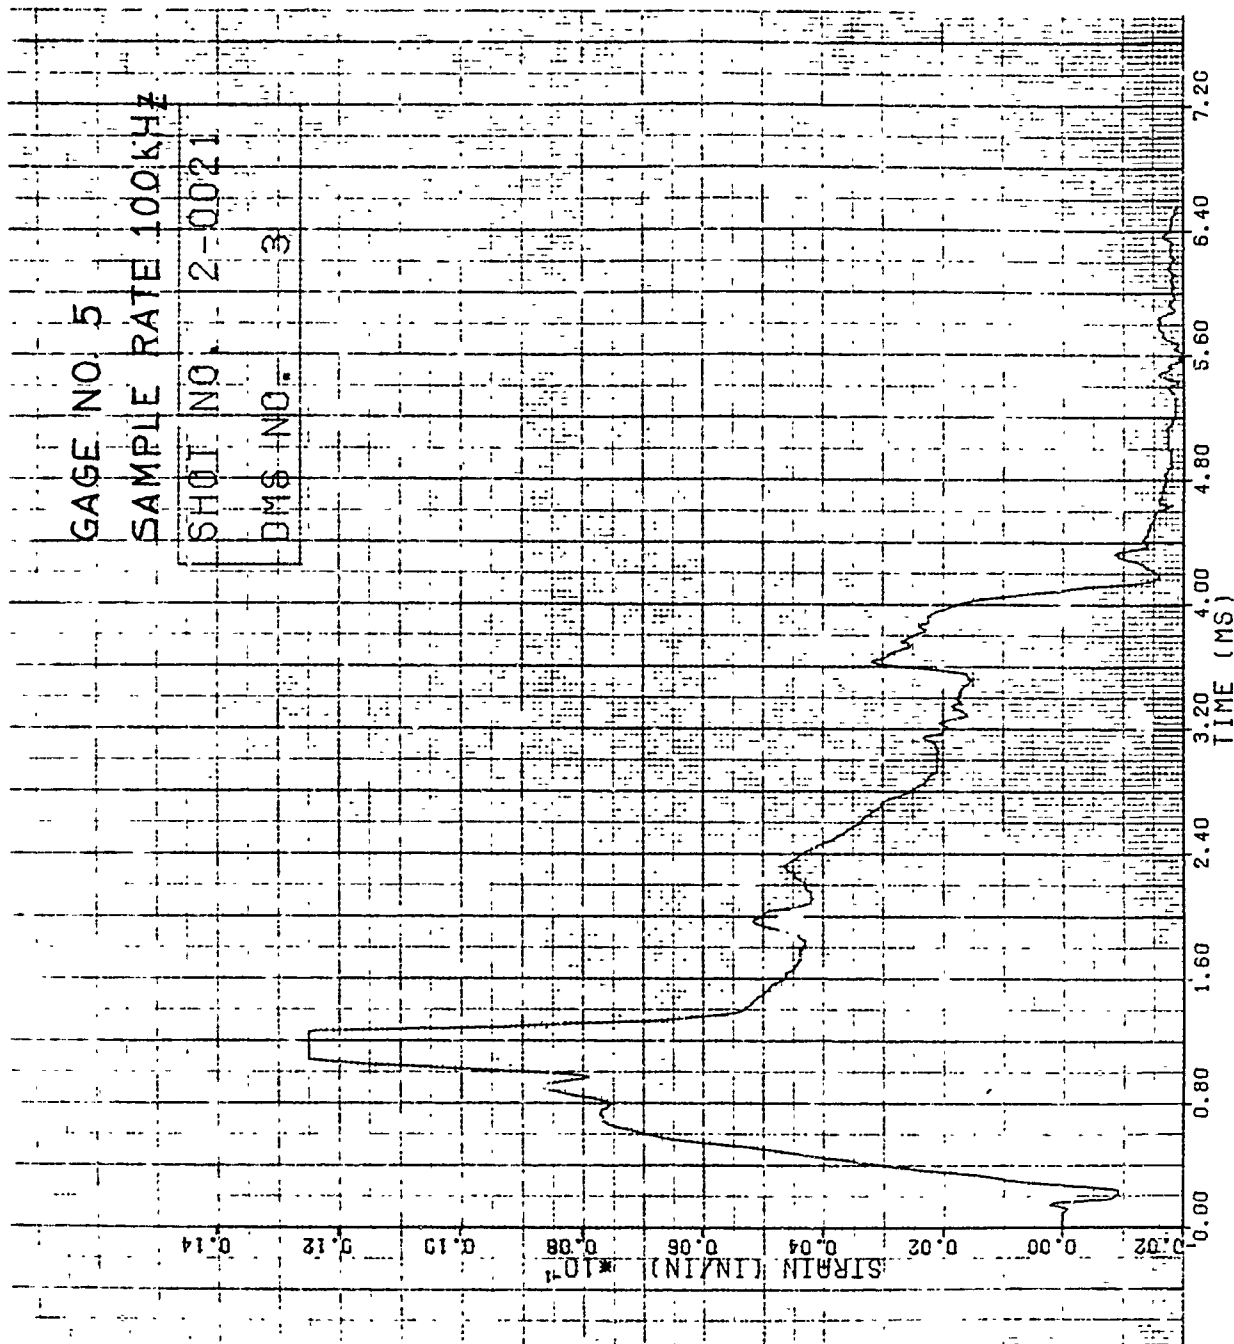
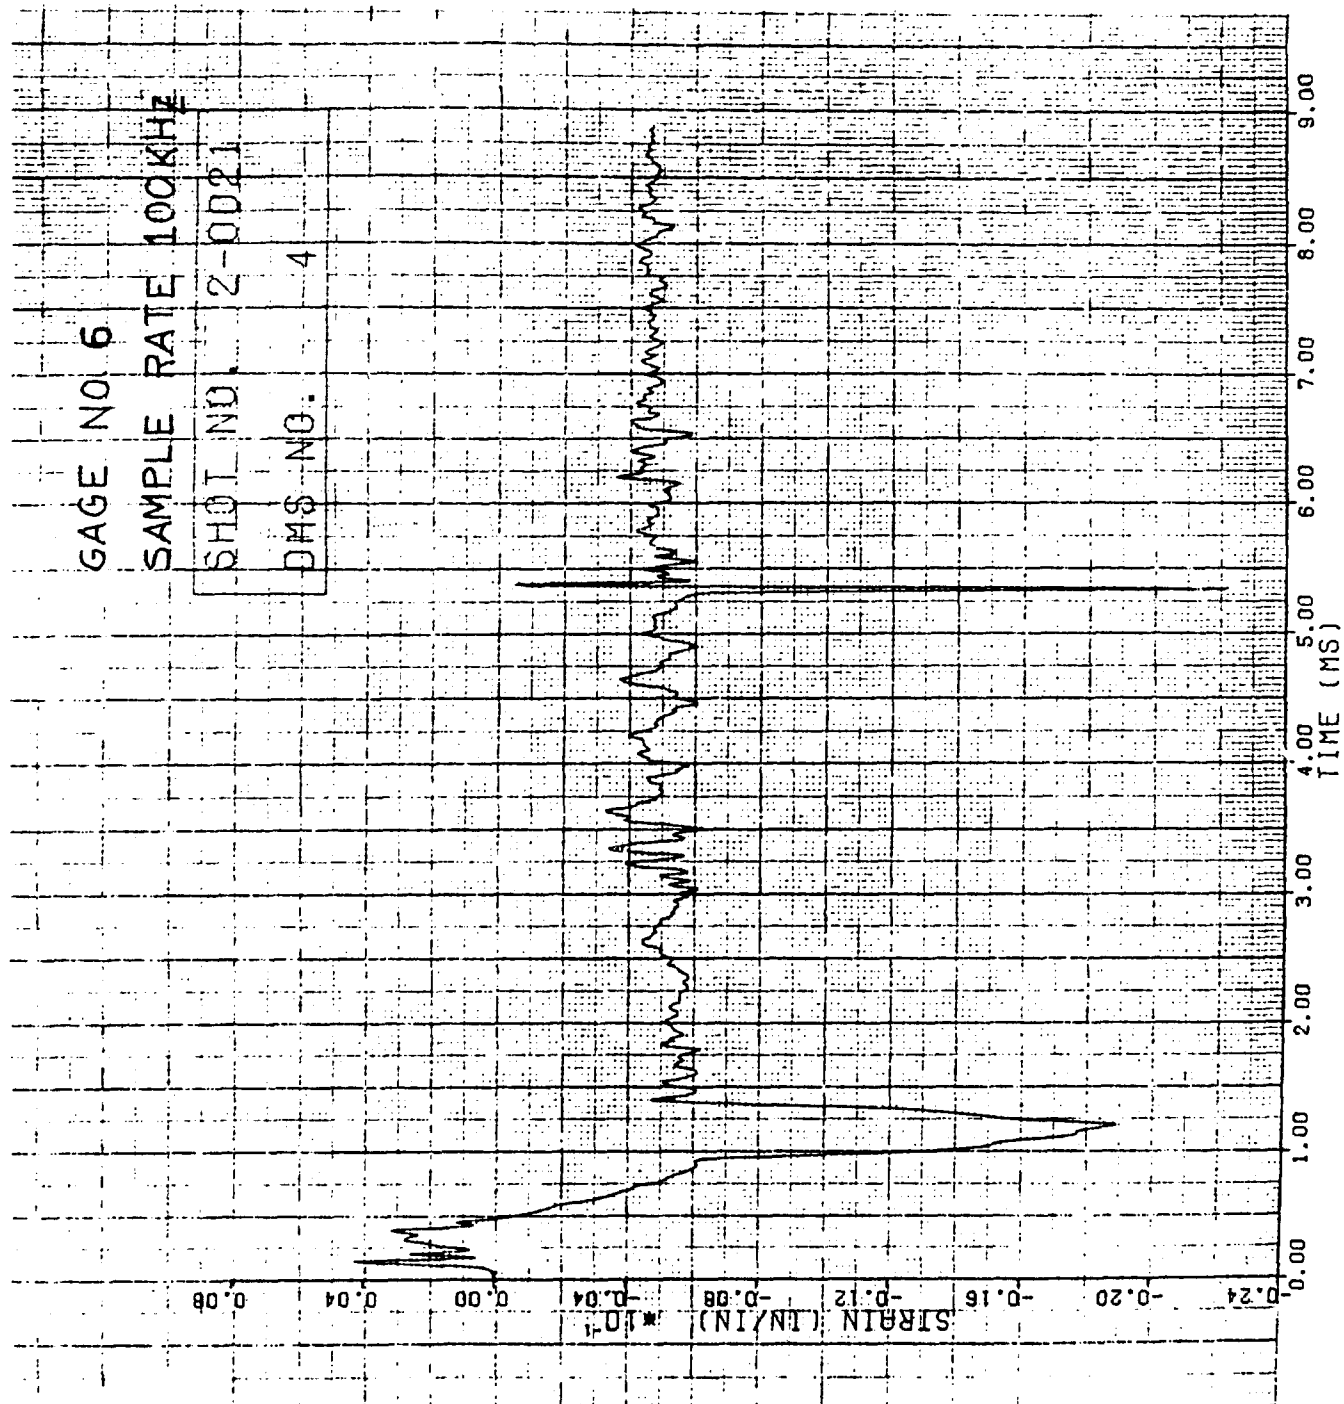
One leading edge impact (Shot 2-0021) using the small 85 g (3 ounce) size bird generated damage on the J79 stainless steel blade in the form of bowing at the impact site. The balsa wood sabot also hit the blade. The impact velocity for the 70 percent span location impact was 300 m/s and the impact mass was 28.0 grams. The angle of incidence was 36.4 degrees.

The strain versus time curves for Shot 2-0021 are given in Figures 216 through 221. The strain gage locations are given in Figure 2A of Appendix A. Tension is denoted as a negative strain and compression as a positive strain in the strain data curves. Figure 48B shows the damage received on the J79 blade from Shot 2-0021.

Figure 216. Strain of Shot 2-0021 for Gage #1.

Figure 217. Strain of Shot 2-0021 for Gage #2.

Figure 218. Strain of Shot 2-0021 for Gage #3.

Figure 219. Strain of Shot 2-0021 for Gage #4.

Figure 220. Strain of Shot 2-0021 for Gage #5.

Figure 221. Strain of Shot 2-0021 for Gage #6.
